Sulphide stress cracking of a valve stem of duplex stainless steel

The present paper describes a failure investigation of a double disc valve stem made of duplex stainless steel 329 (UNS S32900). The valve stem which operated in moist H₂S environment at 128 °C in a heavy water plant had undergone cracking during operation. The microstructure of the stem material showed precipitates of σ -phase at ferrite/austenite boundaries and elongated oxide inclusions. The formation of σ -phase had occurred during the manufacturing stage of the stem. The crack propagation was more favourable in the ferrite phase and along the ferrite/austenite boundaries where precipitates of σ -phase were formed. It was concluded that the valve stem failed by sulphide stress cracking due to hydrogen embrittlement of ferrite phase. Recommendations to avoid such failures are also suggested.

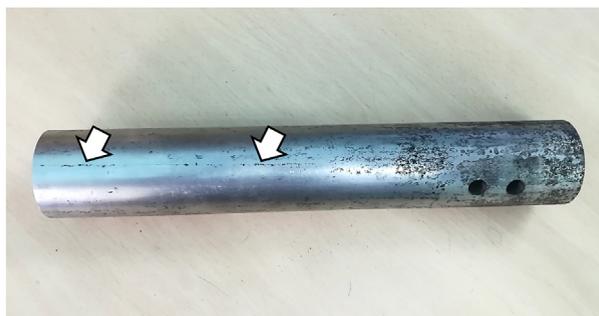
Fig. 1. The image of the failed valve stem showing corrosion attack and axial cracks (indicated by arrows) at several locations.

A double disc valve stem (diameter 62 mm) made of duplex SS 329 (UNS S32900) in a heavy water plant failed due to cracking during operation. The photograph of the failed stem is presented in Fig. 1 that shows a long longitudinal crack (indicated by arrows). There were several other cracks as well as patches of corrosion attack on the cylindrical surface of the stem. The stem was used in a moist H_2S gas environment at pH = 4 and at a temperature and a pressure of 128 °C and 19 Kg/cm² respectively. The valve stem was in service for 30 years.

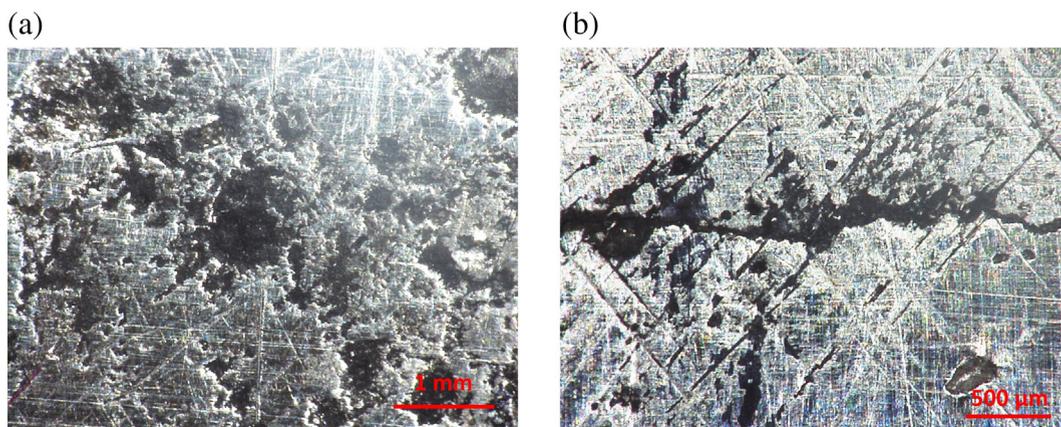
The cylindrical surface of the failed stem was examined at higher magnifications using a stereo microscope. Fig. 2a shows corrosion attack on the surface as several shallow pits. One of the cracks on the cylindrical surface of the failed stem rod is shown in Fig. 2b. It appears that the corroded regions or pits on the surface are joined together to form a large crack.

Fig. 2. Stereo micrographs of the cylindrical surface of the failed stem showing (a) corrosion attack in the form of wide and shallow pits and (b) one of the several cracks.

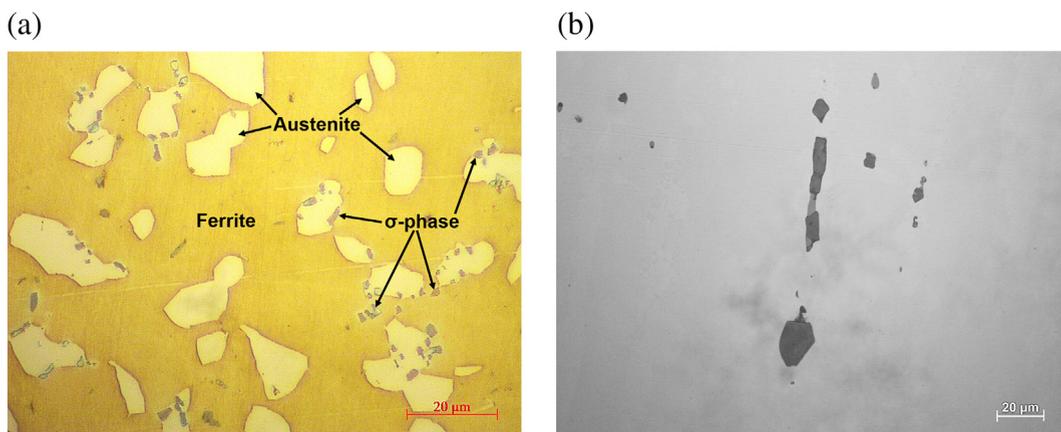
A typical etched microstructure of stem away from the crack is shown in Fig. 3a consisting of austenite islands (light-color etched) in ferrite matrix (dark-color etched). In addition, small-sized precipitates of red/orange color are also observed which are mostly concentrated at the ferrite/austenite boundaries and within the ferrite phase. These precipitates were identified as σ -phase based on their red/orange color after electrolytic etching in KOH solution as per ASTM standard E407 [14]. Such a distribution of σ -phase at ferrite/austenite boundaries is also reported in literature [15]. The stem material also contained large inclusions which were of almost spherical shape when viewed on the transverse section. However, when examined on the longitudinal section, these inclusions were found to be elongated along the axis of the stem. A typical elongated inclusion on the as-polished longitudinal surface is shown in Fig. 3(b).

Fig. 3. Optical micrographs showing (a) the typical microstructure of duplex SS 329 stem on the transverse section after electrolytic etching in 45% KOH solution consisting of ferrite, austenite and precipitates of σ -phase and (b) elongated inclusions on the as-polished longitudinal surface.

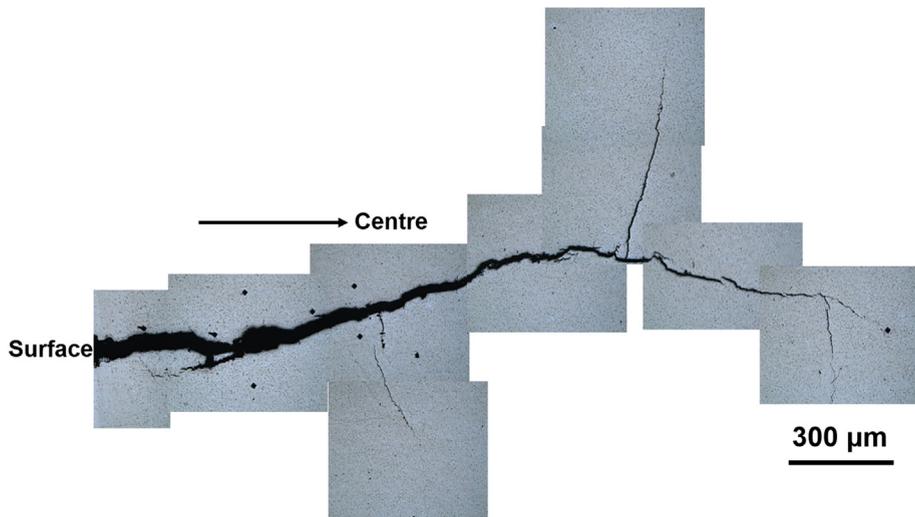
Fig. 4 is the montaz of optical microscopic images of the cross-section of stem showing the full length of a crack. The crack is observed to be initiated at the surface and has propagated to the transverse direction of the stem, i.e., in a direction perpendicular to the axis of the stem. There is not much branching of the crack. In general, the cracks were very wide and their typical propagation through the duplex phases of ferrite and austenite on the etched microstructure is shown in Fig. 5a. The optical micrograph in Fig. 5b is taken near the crack tip. It is evident that the cracks are more likely to propagate in the ferrite phase and along the ferrite/austenite boundaries where precipitates of σ -phase are located. Once the austenite phase is encountered along the crack path, either the cracks are stopped or they change their path to remain in the ferrite phase (Fig. 5b).

Fig. 4. Montaz of optical micrographs on the cross-section of the failed stem showing the propagation of a crack in the transverse direction starting from the surface.

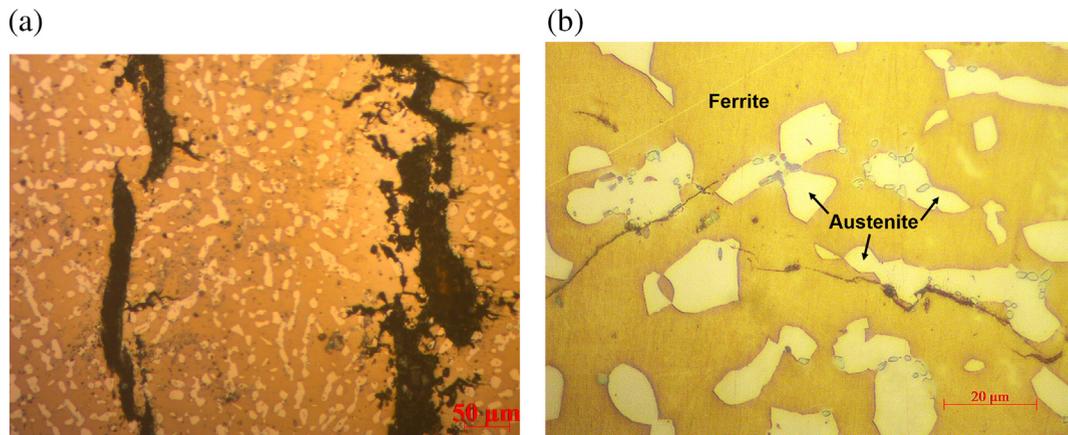
Fig. 5. Optical micrographs of the failed stem on the transverse section after electrolytic etching in 45% KOH solution showing (a) crack propagation path within ferrite and austenite phases and (b) the region near the crack tip. The cracks are more likely to propagate within the ferrite phase and along the ferrite/austenite interfaces where precipitates of σ -phase are present.

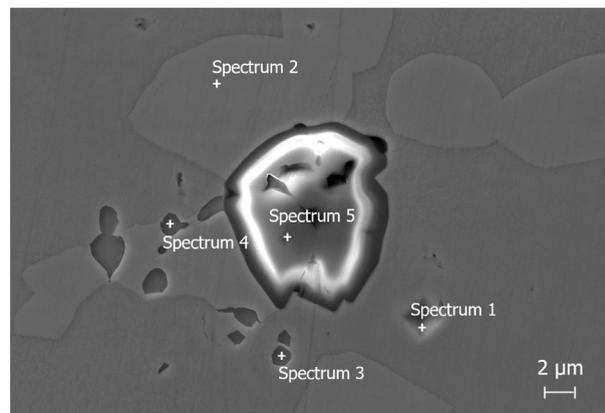
Scanning electron microscope (SEM) attached with energy dispersive spectroscope (EDS) was used to analyze the type of inclusion and to conclusively confirm the presence of σ -phase in the microstructure of stem material. The SEM micrograph in Fig. 6 shows the typical microstructure of duplex SS stem on the transverse section. Ferrite and austenite phases are distinguished by their color contrast (austenite is brighter than ferrite). The rounded particle at the centre of micrograph (Fig. 6) shows an inclusion in the stem. The chemical compositions of small precipitates (dark grey in color) formed in ferrite and at ferrite/austenite boundaries and that of inclusion were analyzed using point EDS and the results are presented in Table 2. The chemical compositions of individual ferrite and austenite phases were also measured and are shown in Table 2. The compositions of only major alloying elements are considered

Fig. 6. SEM micrograph of the transverse section of duplex SS 329 stem showing a large inclusion. Also marked are the locations where point EDS was performed corresponding to which the compositions are presented in Table 2.

here. The phases/precipitates on which point EDS were performed are marked in Fig. 6. As expected, ferrite phase is enriched with ferrite stabilizing elements such as Cr, Mo and Si and lean in austenite stabilizing elements such as Ni and Mn. The reverse is the case for austenite phase, i.e., it is enriched in Ni and Mn and lean in Cr, Mo and Si. The precipitates formed in ferrite and at ferrite/austenite boundaries are highly enriched in Cr and Mo indicating that these must be σ -phase in agreement with the optical microscopic results. Sigma-phase is comparatively richer in Cr and Mo than the matrix [1, 15]. The chemical composition of inclusion shows high contents of O, Cr and Mn (Table 2) indicating that duplex SS stem contained oxide-type inclusions in the microstructure.
